**NAVAL WEAPONS STATION,  
SEAL BEACH  
NAVAL STATION LONG BEACH  
FLEET MOORINGS UNDERWATER  
INSPECTION PLAN**

23 AUGUST 1982

**NWS SEAL BEACH/NAVSTA LONG BEACH  
FLEET MOORING UNDERWATER  
INSPECTION PLAN**

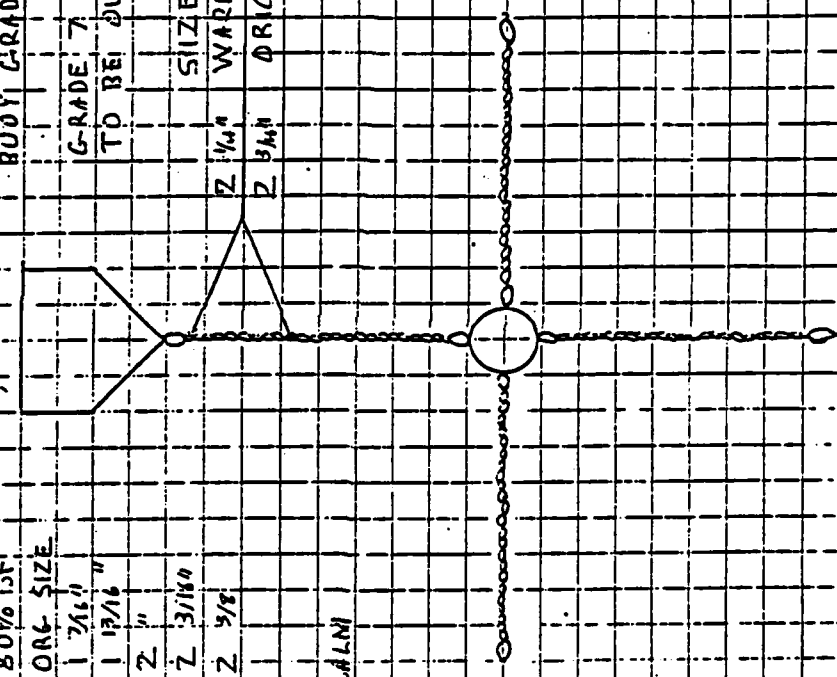
ALPHA 1

No Z's installed  
This is a Fiberglass  
buoy

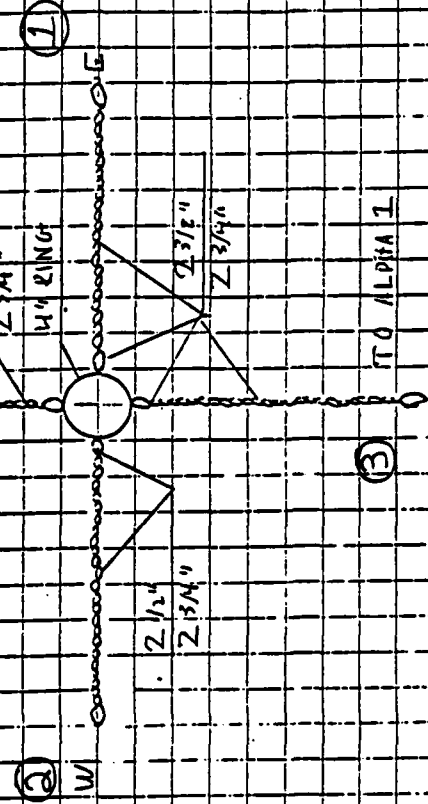
MOORING NO. ALPHA 13

Buoy was from  
OSC 5, a drum  
buoy 8' x 14' 0"  
Buoy was overhauled  
and 21042 installed

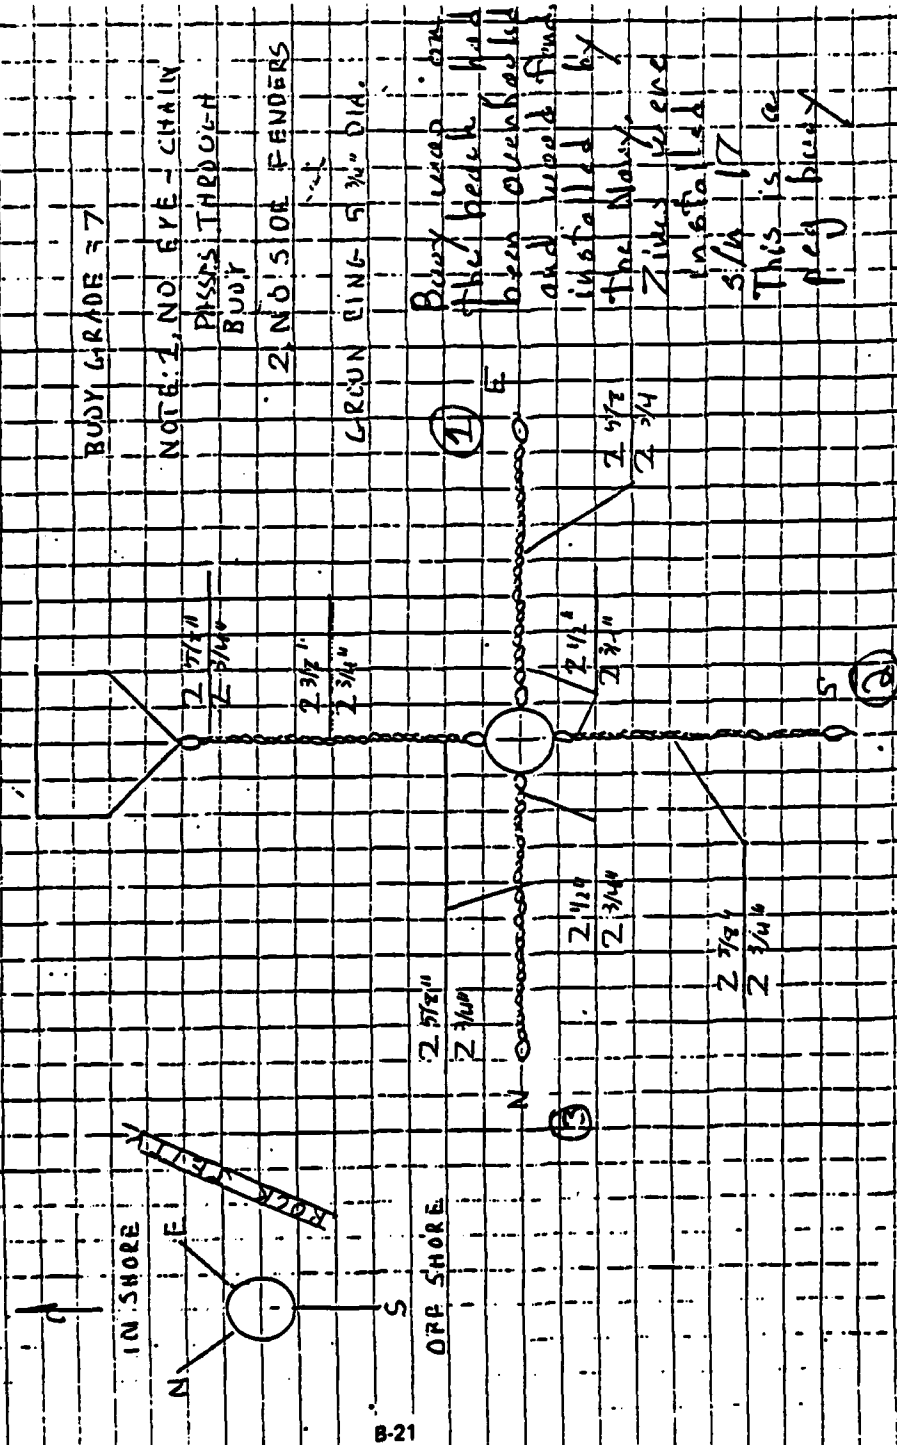
Note The anchor  
and chain are  
badly sandblasted
